# Manhole Inspection Summary

Manhole # S41Y1\_029MH

Insp Date: **11/30/07 6:58 AM**

**Location** Address: **3700 7th St**

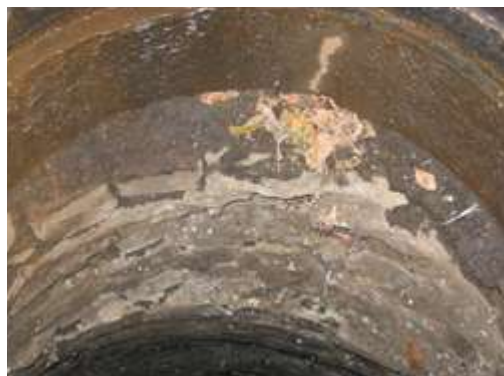
Defect 1

**Frame** Offset: **4** (in.) Condition: ☒ Sound ☐ Cracked ☐ Leaks

Frame offset

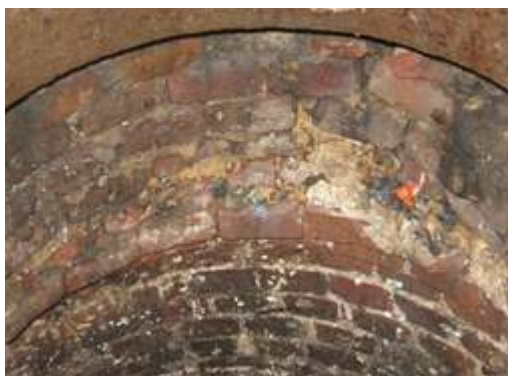
Defect 2

Condition: ☐ Sound ☒ **Cracked** ☐ Root Intrusion ☒ **Loose Brick** ☐ Deteriorated

Infiltration: ☐ None ☒ **Joint** ☒ **Cracks** ☒ **Mortar** ☐ Roots ☒ **Wall**

Chimney infiltration/cracks/loose bricks

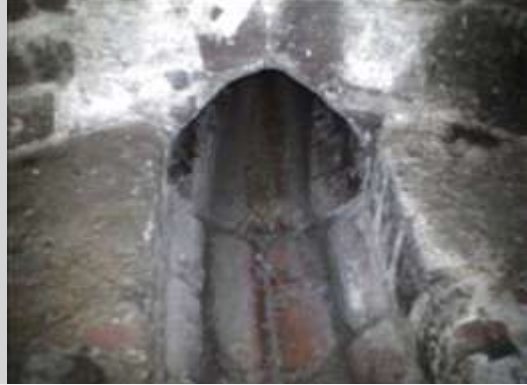
12 O'Clock Outflow

8 in. Circular Gravity Sewer  
Pipe Out @ 12 O'Clock

Pipe Height: **10.8** (in.) Rod and Bar (Angled)  
Pipe Material: **Clay** ☐ Pipe Lined  
Invert Depth: **8.88** (ft.) Flow Characteristics: **Fast**  
Deposits: ☒ None ☐ Mud ☐ Sludge ☐ Debris ☐ Grease  
Silt Depth: (in.) Deposits Extent:  
Infiltration: **None** Pipe Seal Cond: **Sound**

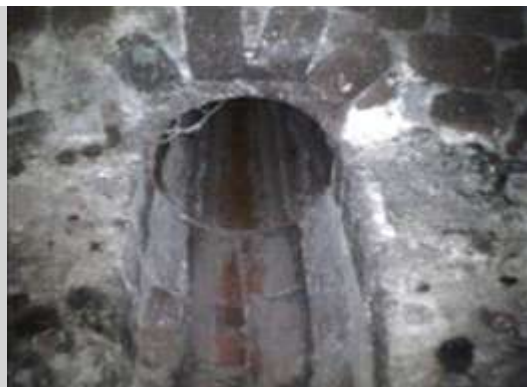
3 O'Clock Inflow

8 in. Circular Gravity Sewer  
Pipe In @ 3 O'Clock

Pipe Height: **10.8** (in.) Rod and Bar (Angled)  
Pipe Material: **Clay** ☐ Pipe Lined  
Invert Depth: **8.72** (ft.) Flow Characteristics: **Fast**  
Deposits: ☒ None ☐ Mud ☐ Sludge ☐ Debris ☐ Grease  
Silt Depth: (in.) Deposits Extent:  
Infiltration: **None** Pipe Seal Cond: **Sound**
